Manhole Inspection Summary

Manhole # S29Q__014MH

Insp Date: 11/5/08 1:07 PM

Location Address: **1267 Scott St**

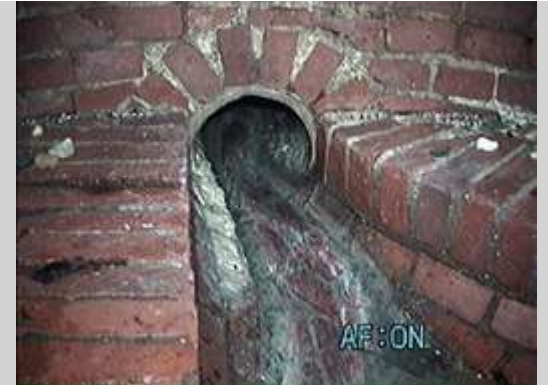
12 O'Clock Outflow

8 in. Circular Gravity Sewer
Pipe Out @ 12 O'Clock

Pipe Height: **8.4** (in.) Rod and Bar (Angled)
Pipe Material: **Clay** ☐ Pipe Lined
Invert Depth: **11.06** (ft.) Flow Characteristics: **Slow**
Deposits: ☒ None ☐ Mud ☐ Sludge ☐ **Debris** ☐ Grease
Silt Depth: **0** (in.) Deposits Extent:
Infiltration: **None** Pipe Seal Cond: **Sound**

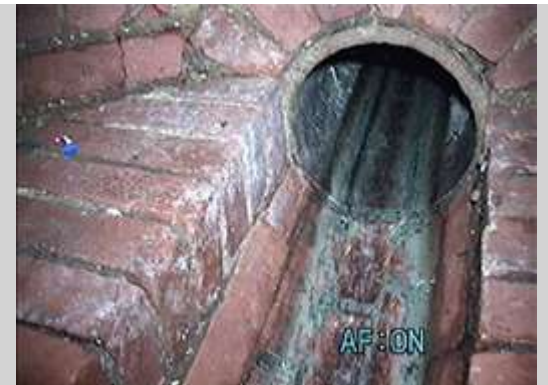
3 O'Clock Outflow

6 in. Circular Gravity Sewer
Pipe Out @ 3 O'Clock

Pipe Height: **6** (in.) Rod and Bar (Angled)
Pipe Material: **Clay** ☐ Pipe Lined
Invert Depth: **10.72** (ft.) Flow Characteristics: **Slow**
Deposits: ☒ None ☐ Mud ☐ Sludge ☐ **Debris** ☐ Grease
Silt Depth: **0** (in.) Deposits Extent:
Infiltration: **None** Pipe Seal Cond: **Sound**
